Preliminary Analysis Report

Prepared by Wesley Grimes

Bryson v. Rough Country, LLC Mecanica Case Number: 22-3104 Date of Collision: March 15, 2020

Location of Crash: Intersection of Georgia 2 and Georgia 5 Blue Ridge, Fannin County, Georgia

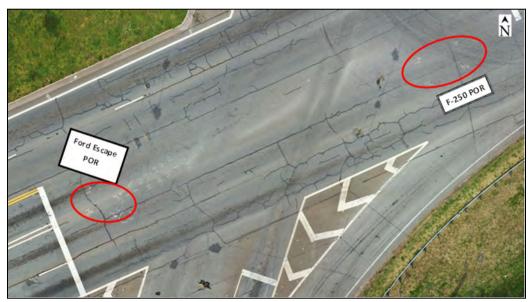
Figure 2 is an orthomosaic created from drone aerial photographs of the site showing a close-up of the intersection. In the orthomosaic (**Figure 3**) the police markings indicating the rest positions of the vehicles were observed. From the SCRT Report, the F-250 was moved after it originally came to rest. The police report identified the collision site as 25 feet east of Blue Ridge Drive on Georgia 2.

Figure 3: GDPS aerial view with points of rest marked

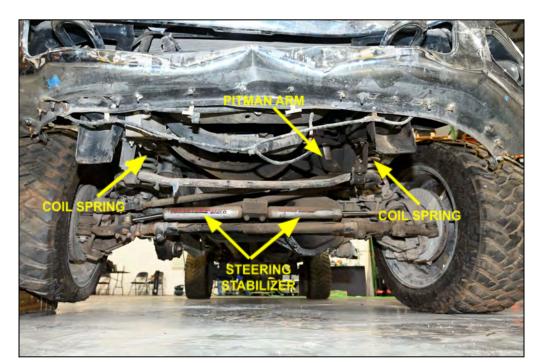
The aftermarket lift kit from Rough Country was installed on the F-250 before this incident. The kit included coil springs, radius arm drop brackets, sway-bar drop brackets, track bar drop brackets, stabilizer relocation brackets, pitman arm, brake lines, brake line brackets, shock absorbers, bump stop spacers, lift blocks, U-bolts, and attachment hardware (Figures 4 and 5). In addition, the pickup had a steering stabilizer and larger tires and wheels than original equipment.

Figure 4: Front underbody of F-250 showing various aftermarket components

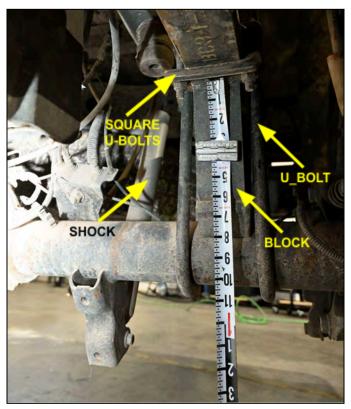
Figure 5: Rear underbody of F-250 showing aftermarket components

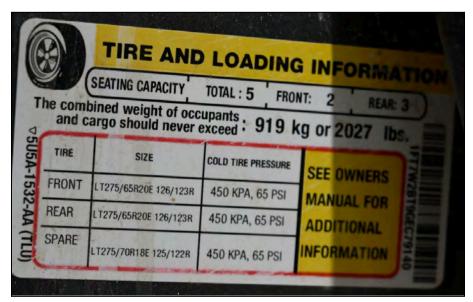
On page 6 of the report, Mr. Buchner used a 2015 Ford F-250 Super Duty, Crew Cab, four-wheel drive pickup with LT275/70R18 tires as an exemplar vehicle. Although the VIN for Mr. Buchner's exemplar F-250 was not given, the Tire and Loading Information decal on the left B-pillar of the subject vehicle (**Figure 25**) shows the recommended tire size for the subject F-250 was LT275/65R20. The difference between the diameter of the tire sizes of Mr. Buchner's exemplar F-250 and the recommended tire size of the subject F-250 is approximately one inch. This would decrease the height of Mr. Buchner's F-250 by approximately one half inch over the 2016 Ford F-250 involved in this crash.

Figure 25: Tire and Loading Information from the Subject F-250

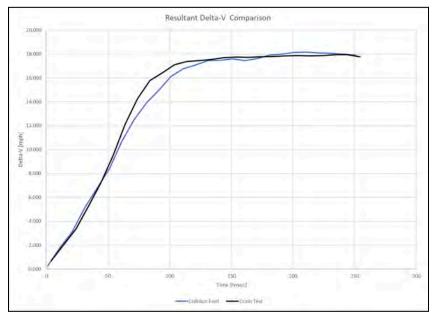
Table 1 contains a comparison of vehicle impact speeds and delta-Vs for the crash and the test that was conducted.

Figure 29: Resultant delta-V comparison between crash test and collision F-250.

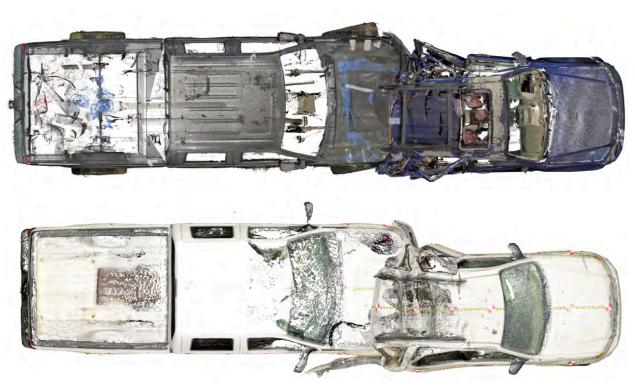
Figure 39 shows the alignment comparison of the subject vehicles and that achieved for the test vehicles at maximum static crush. Based on the analyses and crash test performed, the deformation and accelerations of the Escape would have been substantially similar whether the F-250 was lifted or was equipped with a stock suspension. Vehicle outlines were then placed over the vehicle point clouds and the point clouds were then removed (Figure 40). The dimension was then measured from the front bumper of the F-250 to the front bumper of the Escape. This dimension was 10.6 feet and 9.9 feet for the subject vehicles and the test vehicles, respectively. This means the crash test had more intrusion than the subject vehicle from the crash.

Figure 39: Alignment comparison of subject vehicles (top) and test vehicles (bottom) at maximum mutual crush.

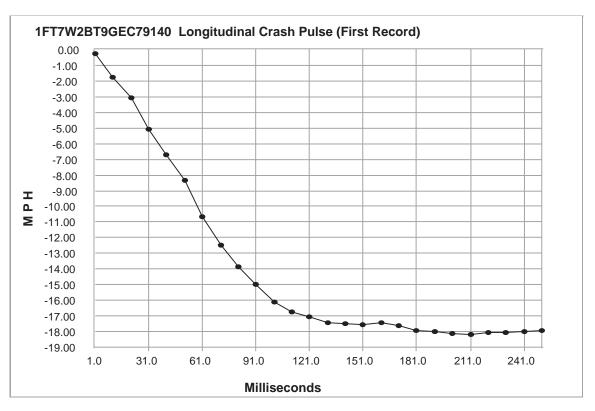
Longitudinal Crash Pulse (First Record)

Time (msec)	Delta-V, longitudinal (MPH)	Delta-V, longitudinal (km/h)
1.0	-0.25	-0.40
11.0	-1.79	-2.87
21.0	-3.10	-4.99
31.0	-5.10	-8.20
41.0	-6.73	-10.82
51.0	-8.35	-13.43
61.0	-10.64	-17.12
71.0	-12.46	-20.06
81.0	-13.88	-22.34
91.0	-14.96	-24.07
101.0	-16.13	-25.96
111.0	-16.76	-26.97
121.0	-17.08	-27.49
131.0	-17.44	-28.07
141.0	-17.48	-28.14
151.0	-17.59	-28.30
161.0	-17.45	-28.08
171.0	-17.62	-28.35
181.0	-17.90	-28.81
191.0	-17.99	-28.95
201.0	-18.14	-29.20
211.0	-18.16	-29.23
221.0	-18.08	-29.10
231.0	-18.06	-29.07
241.0	-17.99	-28.95
251.0	-17.92	-28.83

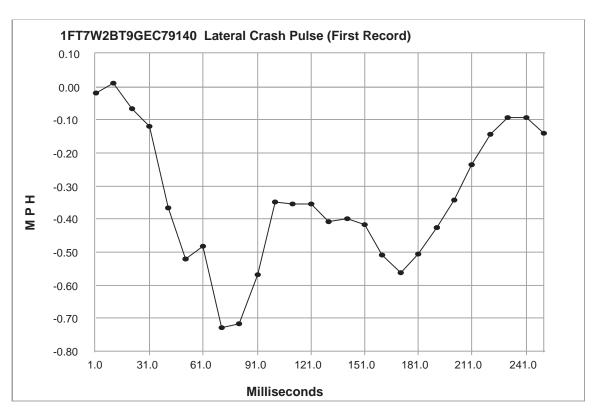
Lateral Crash Pulse (First Record)

Time (msec)	Delta-V, lateral (MPH)	Delta-V, lateral (km/h)
1.0	-0.02	-0.03
11.0	0.01	0.02
21.0	-0.07	-0.11
31.0	-0.12	-0.19
41.0	-0.37	-0.59
51.0	-0.52	-0.84
61.0	-0.48	-0.78
71.0	-0.73	-1.17
81.0	-0.72	-1.15
91.0	-0.57	-0.92
101.0	-0.35	-0.56
111.0	-0.35	-0.57
121.0	-0.35	-0.57
131.0	-0.41	-0.66
141.0	-0.40	-0.64
151.0	-0.42	-0.67
161.0	-0.51	-0.82
171.0	-0.56	-0.91
181.0	-0.51	-0.82
191.0	-0.43	-0.69
201.0	-0.34	-0.55
211.0	-0.23	-0.38
221.0	-0.14	-0.23
231.0	-0.09	-0.15
241.0	-0.09	-0.15
251.0	-0.14	-0.22

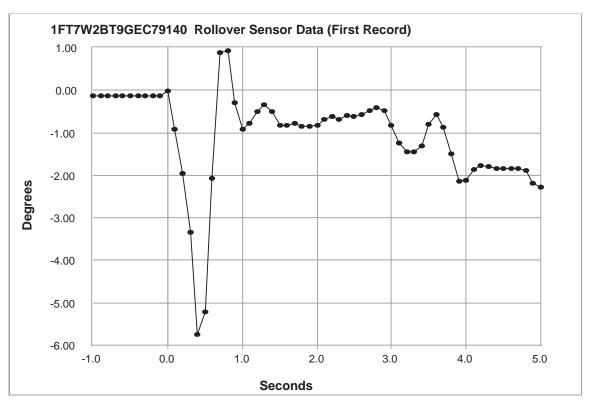
Rollover Sensor Data (First Record)

Time (sec)	Vehicle roll angle (degrees)
-1.0	-0.14
-0.9	-0.13
-0.8	-0.13
-0.7	-0.13
-0.6	-0.13
-0.5	-0.13
-0.4	-0.13
-0.3	-0.13
-0.2	-0.13
-0.1	-0.13
0.0	-0.02
0.1	-0.91
0.2	-1.96
0.3	-3.35
0.4	-5.76
0.5	-5.22
0.6	-2.07
0.7	0.89
0.8	0.93
0.9	-0.29
1.0	-0.92

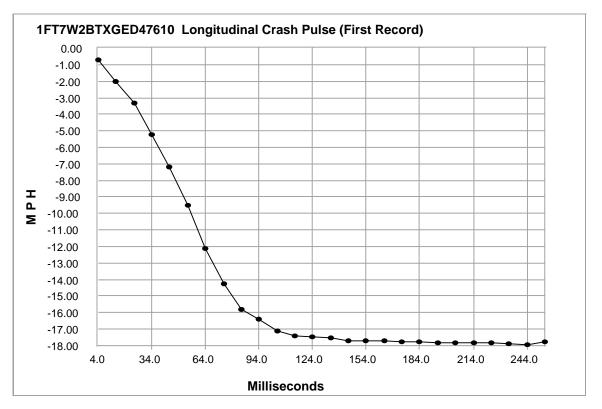
Longitudinal Crash Pulse (First Record)

Time (msec)	Delta-V, longitudinal (MPH)	Delta-V, longitudinal (km/h)
4.0	-0.69	-1.11
14.0	-2.02	-3.26
24.0	-3.35	-5.39
34.0	-5.24	-8.44
44.0	-7.17	-11.55
54.0	-9.48	-15.25
64.0	-12.12	-19.51
74.0	-14.26	-22.95
84.0	-15.78	-25.39
94.0	-16.42	-26.42
104.0	-17.10	-27.52
114.0	-17.38	-27.97
124.0	-17.45	-28.08
134.0	-17.55	-28.25
144.0	-17.69	-28.47
154.0	-17.73	-28.54
164.0	-17.71	-28.50
174.0	-17.76	-28.58
184.0	-17.77	-28.60
194.0	-17.81	-28.66
204.0	-17.84	-28.72
214.0	-17.81	-28.66
224.0	-17.85	-28.72
234.0	-17.91	-28.82
244.0	-17.92	-28.84
254.0	-17.75	-28.57

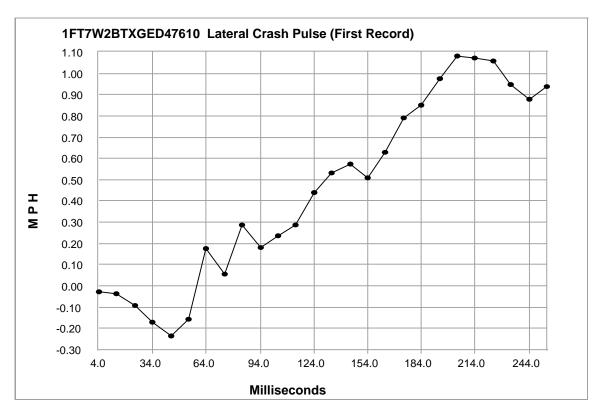
Lateral Crash Pulse (First Record)

Time (msec)	Delta-V, lateral (MPH)	Delta-V, lateral (km/h)
4.0	-0.03	-0.05
14.0	-0.04	-0.06
24.0	-0.09	-0.15
34.0	-0.17	-0.27
44.0	-0.24	-0.38
54.0	-0.16	-0.25
64.0	0.18	0.28
74.0	0.06	0.09
84.0	0.29	0.46
94.0	0.18	0.29
104.0	0.24	0.38
114.0	0.29	0.46
124.0	0.44	0.71
134.0	0.53	0.86
144.0	0.57	0.92
154.0	0.51	0.82
164.0	0.63	1.01
174.0	0.79	1.27
184.0	0.85	1.37
194.0	0.97	1.57
204.0	1.08	1.74
214.0	1.07	1.72
224.0	1.06	1.70
234.0	0.95	1.52
244.0	0.88	1.41
254.0	0.94	1.51
